Škoda Yeti Panoramic Sunroof Leak

This article describes locating and rectifying a catastrophic water leak into the nearside passenger compartment of a six year old Škoda Yeti, which had a standard-fit panoramic sunroof.

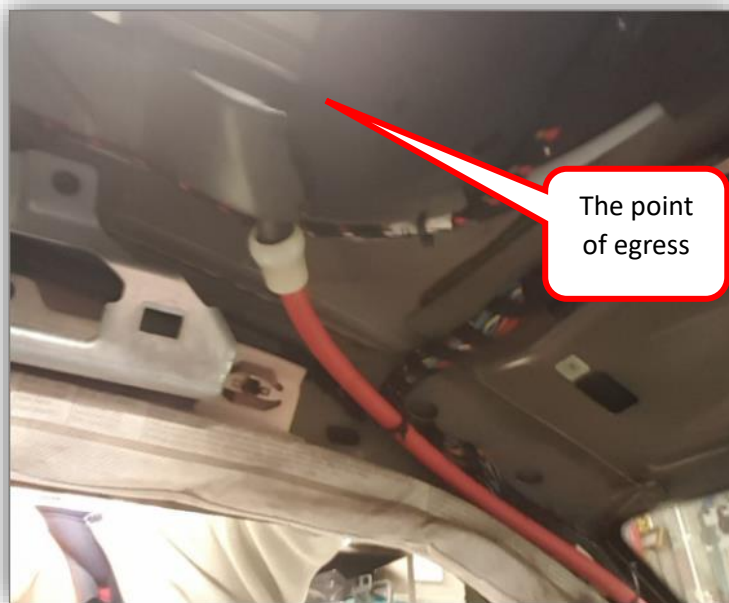
Digging deeper, I removed the headlining, and it was clear that the point from which the leak emanated was some ~60mm *inboard* of the drain tube, as shown in Figure 1 below (apologies for the poor quality).

Figure 1: Picture looking up at the NSF corner of the sunroof from the inside

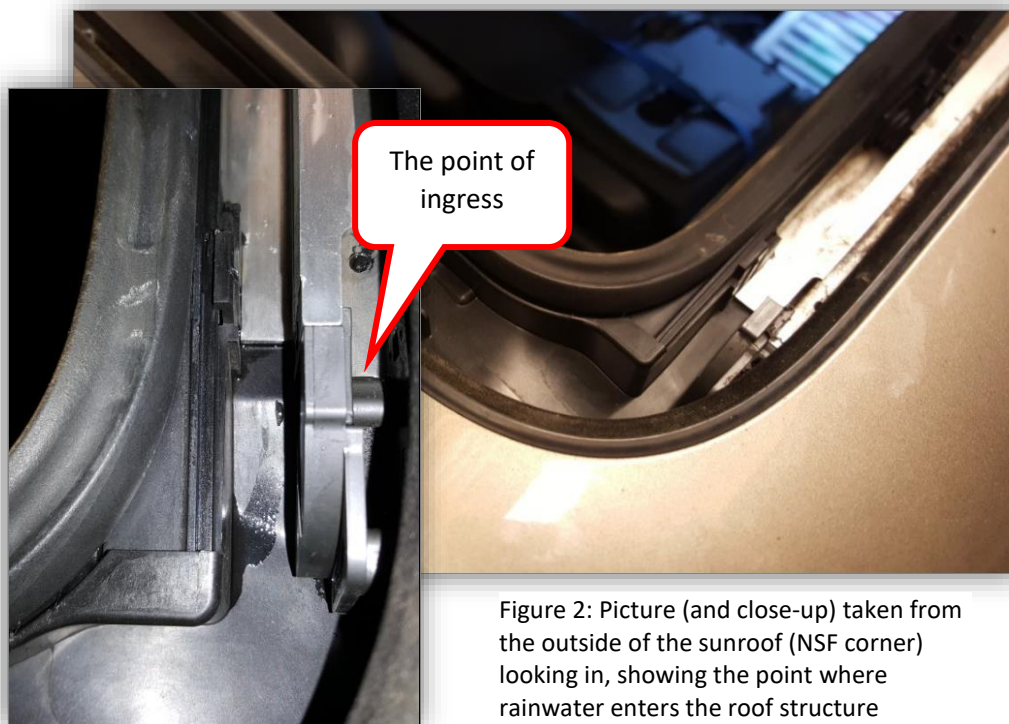
I removed the drain tube and plugged the stub, so I could 'pond' water into this part of the roof, and get a clearer understanding of where the problem was. The drip started at the point when the water breached the interface between the plastic and the aluminium – see Figure 2 below.

Figure 2: Picture (and close-up) taken from the outside of the sunroof (NSF corner) looking in, showing the point where rainwater enters the roof structure

Now let's have a sense-check. Surely if the drain tube was working effectively, water would never 'pond' up to this point? Yes, you'd be right in thinking that, *however* this area is constantly wetted by the rainwater draining past it. If the seal between the two components is compromised, capillary action *will* draw water into the interface between the plastic and the aluminium. Once it's entered, it follows a path through the structure, exiting at the point shown in Figure 1 above.

The viscosity of the sealer is very low. It will run through the crack and out of the other side before you know it, so I applied six or eight separate treatments over the course of three or four days, allowing the sealer to cure properly and build up after each successive treatment.

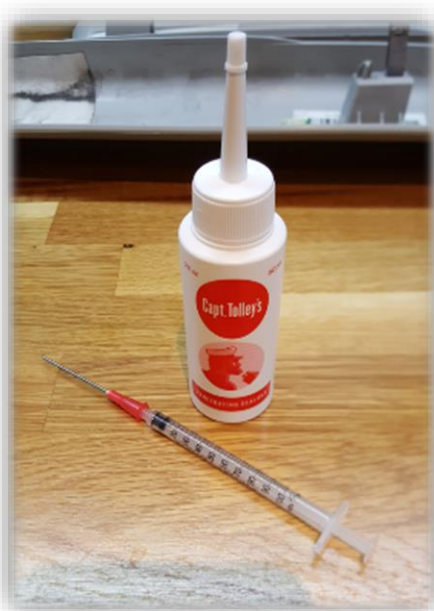
After a bit of research, I found a product called *Captain Tolley's Penetrating Sealer*. This is an emulsion based copolymer product, with a very low viscosity, (and hence excellent penetrating properties) which has good adhesion and remains flexible once set. If you're interested, [here is a link to their website](#) and [here's the spec. sheet](#) for the product.

Figure 3: Captain Tolley's Penetrating Sealer

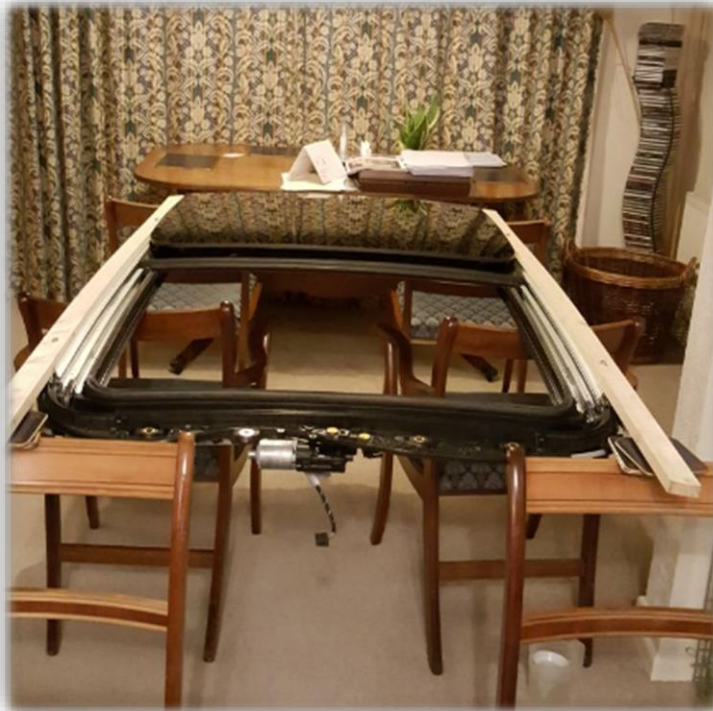
When I reached the point that the gap was fully sealed (i.e. no more sealer was drawn into the join), and it had dried fully, I tested the integrity of each of the four corners by plugging the drain tubes, and running water into each corner to ensure that it retained the water. The testing was done before re-fitting the sunroof to the car - see Figure 4 below.

Figure 4: Testing all four corners of the roof for leakage before re-fitting

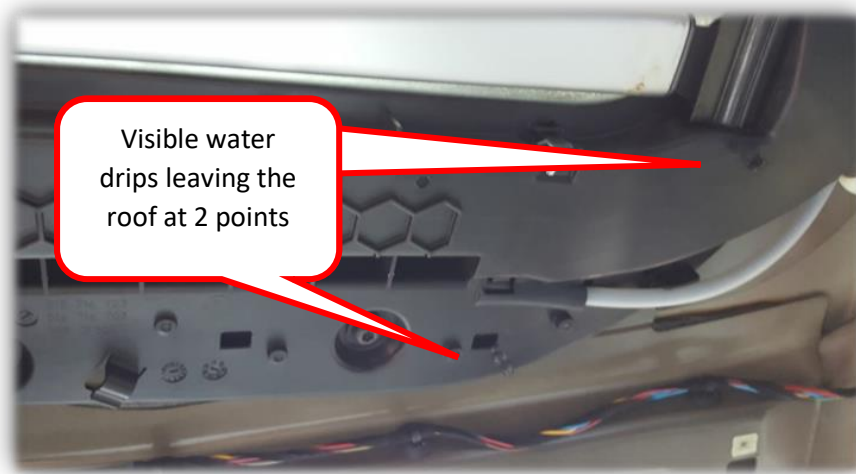
I re-fitted the roof, connected the four drain tubes and left the car out in the rain. The repair was sound, however this time, a new leak appeared from the *offside* front corner. About as severe as if the roof had been left wide open. Clearly the 'trauma' of re-fitting the roof had compromised the already-marginal sealer on the other side. Figure 5 below captures 3 drips of water in a chain. Consider that one drip per second amounts to ~3 litres in a 24 hour period, leaving it out in the rain for a week won't end well.

Figure 5: View of the OSF of the sunroof, looking up from the inside

It was apparent that the roof, in isolation from the car, was even more frail than I had envisaged, and so it was probably better to attempt sealing the O/S without removing the roof again. I cleaned and dried the OSF corner, blew it dry using an airline, and then administered the sealer using the syringe. This time of course the roof was horizontal not vertical, but the syringe enabled me to deliver a precise and controlled amount of sealer to exactly the right area. This time, it was drawn into the gap by capillary action, not gravity, but no less effectively.

Once again, I treated it twice-daily for around three days, and left the final treatment to dry for ~24 hours before moving the vehicle outside for testing. As luck would have it, the rainfall that day was of biblical proportion, providing a pretty extreme test. Without the headlining, any leak would have been readily apparent, but happily ... all was well.

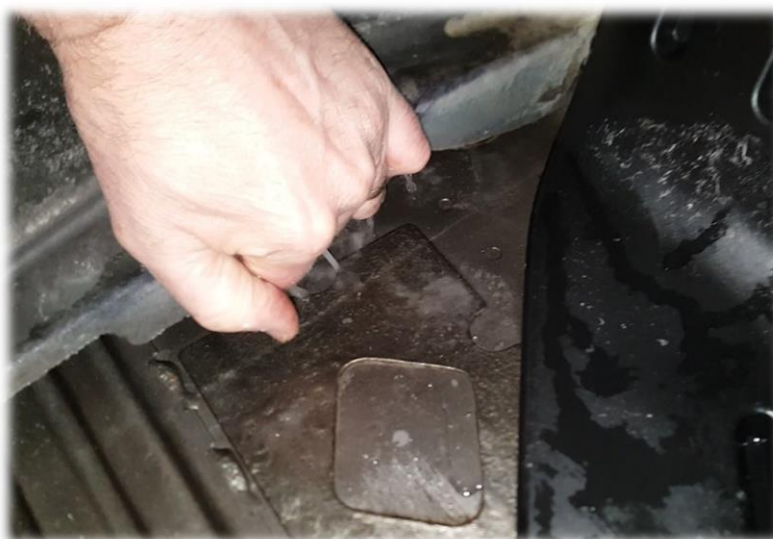
The one part I didn't remove to dry was the ~35mm thick piece of foam rubber lining the toeboard – see Figure 6 below. It was extremely wet, but pulling it out to dry it properly would have entailed removing the dashboard first, and I didn't have the appetite for that. Instead I used best endeavours to dry it over the course of a few days, by squeezing the water out of it, using cat litter and ultimately force-drying it with a

Figure 6: The saturated foam on the N/S toeboard

hair dryer. The result was adequate rather than perfect, but it's not in an air-tight environment, so it will dry out completely over time.

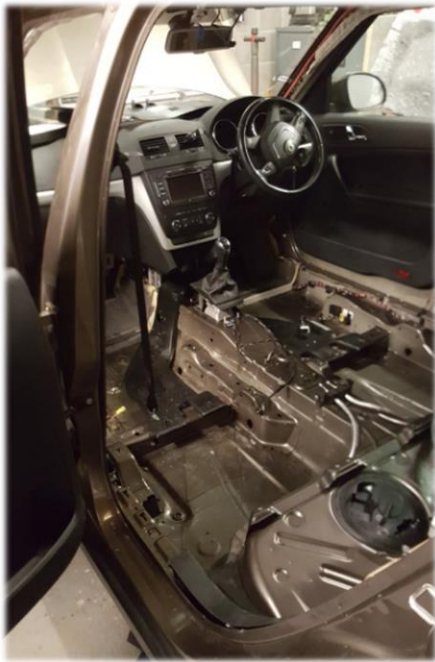
Figure 7: The naked interior

I lifted the carpet and attempted to air dry it and the underlay, but 5 days on there was little improvement. The only viable option was to remove all of the seats, door pillar & kick-plate trims, centre console etc. to get the carpet and underlay out. I moved them into a dryer, warmer environment, where the carpet dried in a couple of days, but the under-carpet felt took a week to dry out completely. I mentioned earlier that the weight of the 'soft furnishings' gave me to believe that there was a further 5 litres absorbed there.
